Technical Note TN-722

Control Head Changes for the T2035

19th July 2002

This Technical Note only applies to the T2035 trunking radio.

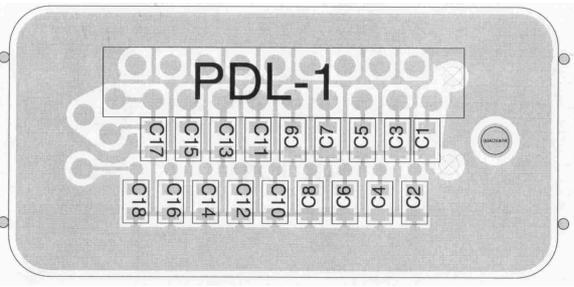
<p>Note</p>	<p>Because the new T2035 control head is a modified T2015 control head there are two changes that need to be carried out to the EMC Filter board. This modification only needs to be carried out if an old type control head is being replaced with a new type control head.</p> <p>The changes are the removal of C4 (150p, IPN 015-23150-01), and the addition of C2 (470p, IPN 015-23470-08)</p>
