## Technical Note TN-786

### T828 Q2 Component Changes

29 July 2003

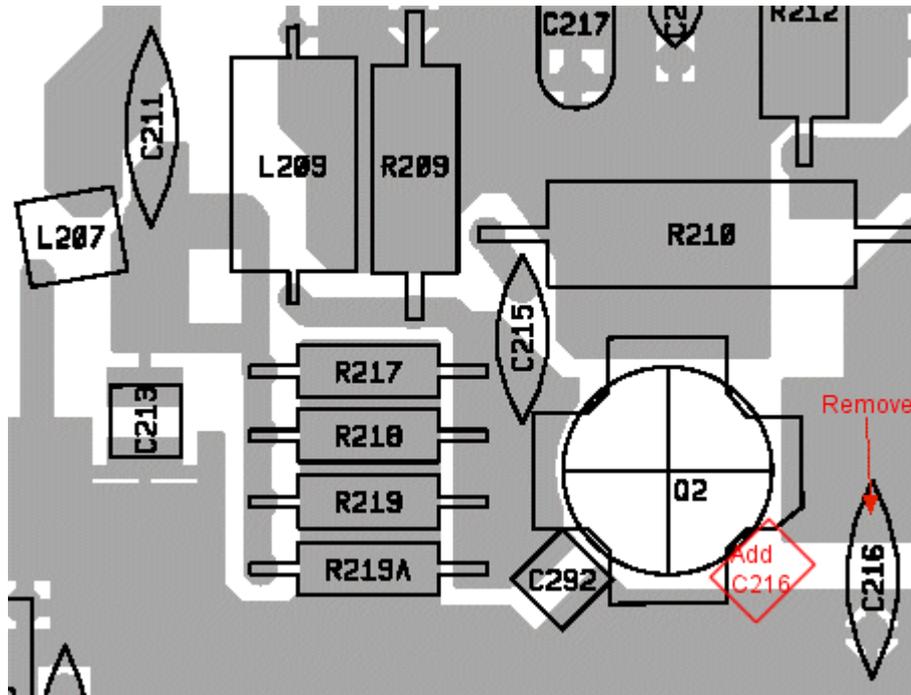
The MRF234 transistor used as the driver in the T828 is no longer available. The SD1272 (IPN 000-00127-20) has been found to be a suitable replacement with a number of component changes. This tech note details these changes which are not in the current manual (M820-00-2A0) at the time of publication of this tech note.

Notes: C216 is removed and replaced with a chip cap as shown below. Other components are in their original locations.
