TECHNICAL NOTE

Technical Note TN-825 TM8000 Mobile radio Release 2 Upgrade Instructions

19 December 2003

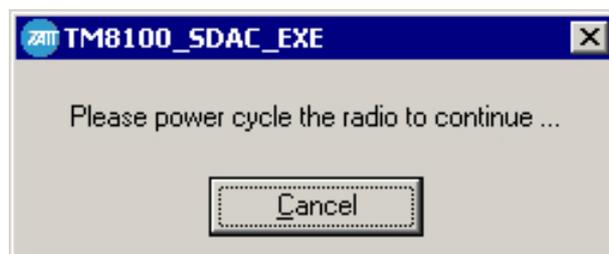
To continue, **remove** the DC supply to the radio and wait 5 seconds then re-apply DC supply

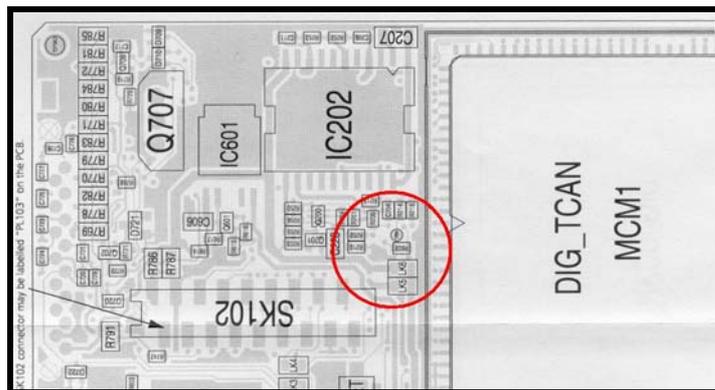
The watchdog timer provides the TM8100 radio with a non system error reset. Should the processor stop for longer than 1200mS the timer will restart the radio.

The watchdog link is R602 located on the top side of the main board between TP200 & LK6. This is a zero ohm 0603 resistor. **IPN** 038-10000-00.

Note: Using the watchdog timer comes with a warning. A watchdog reset will cause a complete processor restart and hence also release the power supply latch signal momentarily.

If power supply LK1 is not fitted, or if the IGN or INT_OPT_PWR signals are not asserted at the time, then the radio will switch off with a watchdog reset and require a manual restart. Thus, the watchdog timer should only be used with special care paid to power link settings and system design if used in remote out-stations etc.

Retro-fitting the watchdog link is entirely optional. This means that if it is not fitted there will be no difference to current operation. However, if the added security of watchdog reset is desired then the decision can be made to fit the link.
